October 14, 2025

Company name: Nippon Carbon Co., Ltd.  
Representative: Takafumi Miyashita,  
Representative Director, CEO  
(Stock code: 5302; Prime Market of the Tokyo  
Stock Exchange)

### Notice Concerning the Fire Incident at the Toyama Plant (Fourth Report)

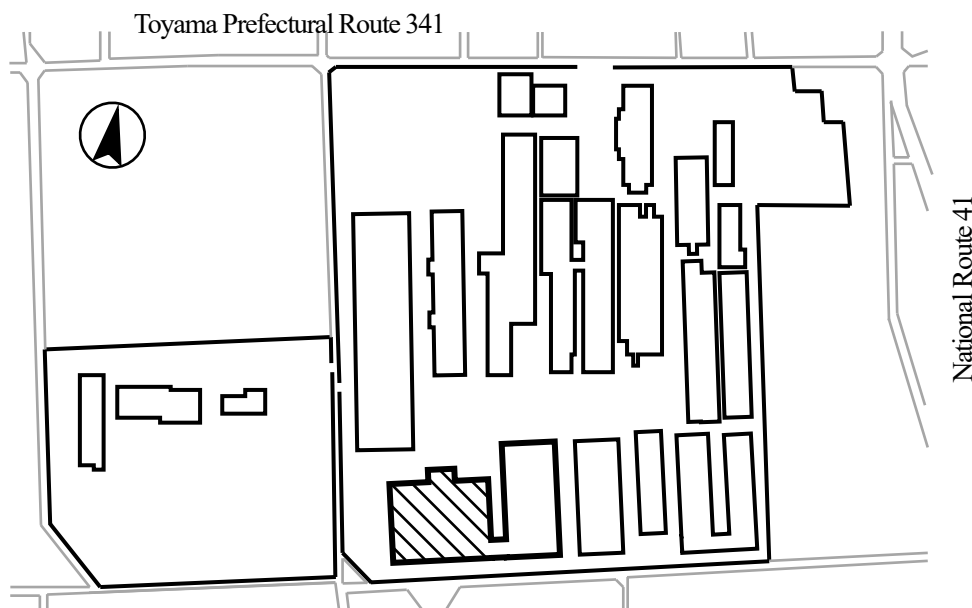
Figure 1: Layout of Buildings within the Premises of the Toyama Plant

At approximately 7:15 a.m. on Friday, August 29, 2025, a fire accompanied by a loud explosive sound in the graphitization furnace facilities used in the production process of artificial graphite electrodes (shaded area in the diagram below). Following firefighting efforts by the fire department, the fire was declared extinguished at 4:00 p.m. on Sunday, August 31.

There were no human casualties among local residents or our employees, and no spread of fire to nearby houses or other structures. The total floor area of the building where the fire occurred is 10,907.45 m<sup>2</sup>. According to an announcement by the fire department, the fire-damaged floor area was 4,440.32 m<sup>2</sup> (classified as partial burn). Please note that this figure has been revised from the initially announced 4,644.9 m<sup>2</sup>.

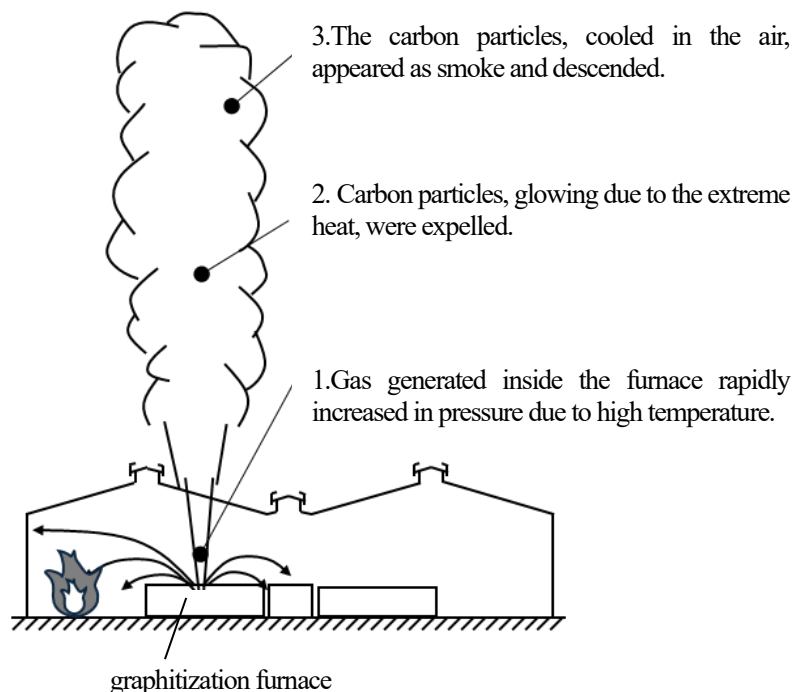
Figure 3: Schematic Diagram of the Phenomena Occurring in the Graphitization Furnace Facilities

First, during the graphitization process, gas generated inside the furnace rapidly increased in pressure due to high temperature, causing high-temperature carbon particles to be ejected from the furnace. The cause of the gas generation is still under investigation.

Next, the resulting pressure surge damaged the building's roof and windows, and carbon particles, glowing due to their extreme heat, were expelled through the roof.

Finally, the expelled carbon particles either oxidized and disappeared due to the heat, or cooled in the air and appeared as smoke before falling to the ground. Some particles scattered inside the building ignited combustible materials.
