October 14, 2025

Company name: Nippon Carbon Co., Ltd.  
Representative: Takafumi Miyashita,  
Representative Director, CEO  
(Stock code: 5302; Prime Market of the Tokyo  
Stock Exchange)

### Notice Concerning the Fire Incident at the Toyama Plant (Fourth Report)

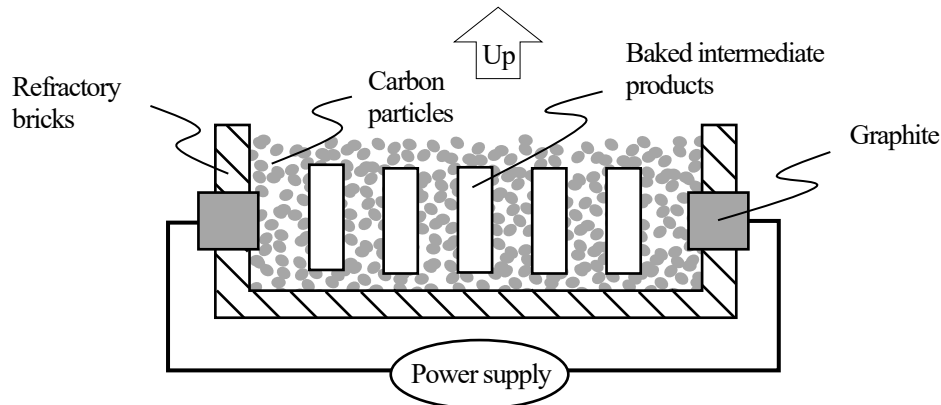
Figure 2: Schematic Cross-Section of the Furnace during Graphitization Process

- (1) Forming: A mixture of coke (produced by carbonizing coal or heavy petroleum oil, with a carbon content of approximately 99% or higher) and pitch (a resin derived from coal) is processed into cylindrical shapes (up to 80 cm in diameter and up to 3 m in length).
- (2) Baking: The formed intermediate products are baked at approximately 1,000°C to carbonize the pitch.
- (3) Graphitization: The baked intermediate products are heat-treated at approximately 3,000°C to grow carbon crystals into graphite. In this process, carbon particles packed around the products inside the furnace are heated above 3,000°C by passing a large electric current through them.

First, during the graphitization process, gas generated inside the furnace rapidly increased in pressure due to high temperature, causing high-temperature carbon particles to be ejected from the furnace. The cause of the gas generation is still under investigation.
